## TECHNICAL SERVICE BULLETIN

### Various Concerns With Active Exhaust System - Built On Or Before 28-Aug-2020

**21-2011**  
25 March 2021

| Ford<br>2020 Mustang |

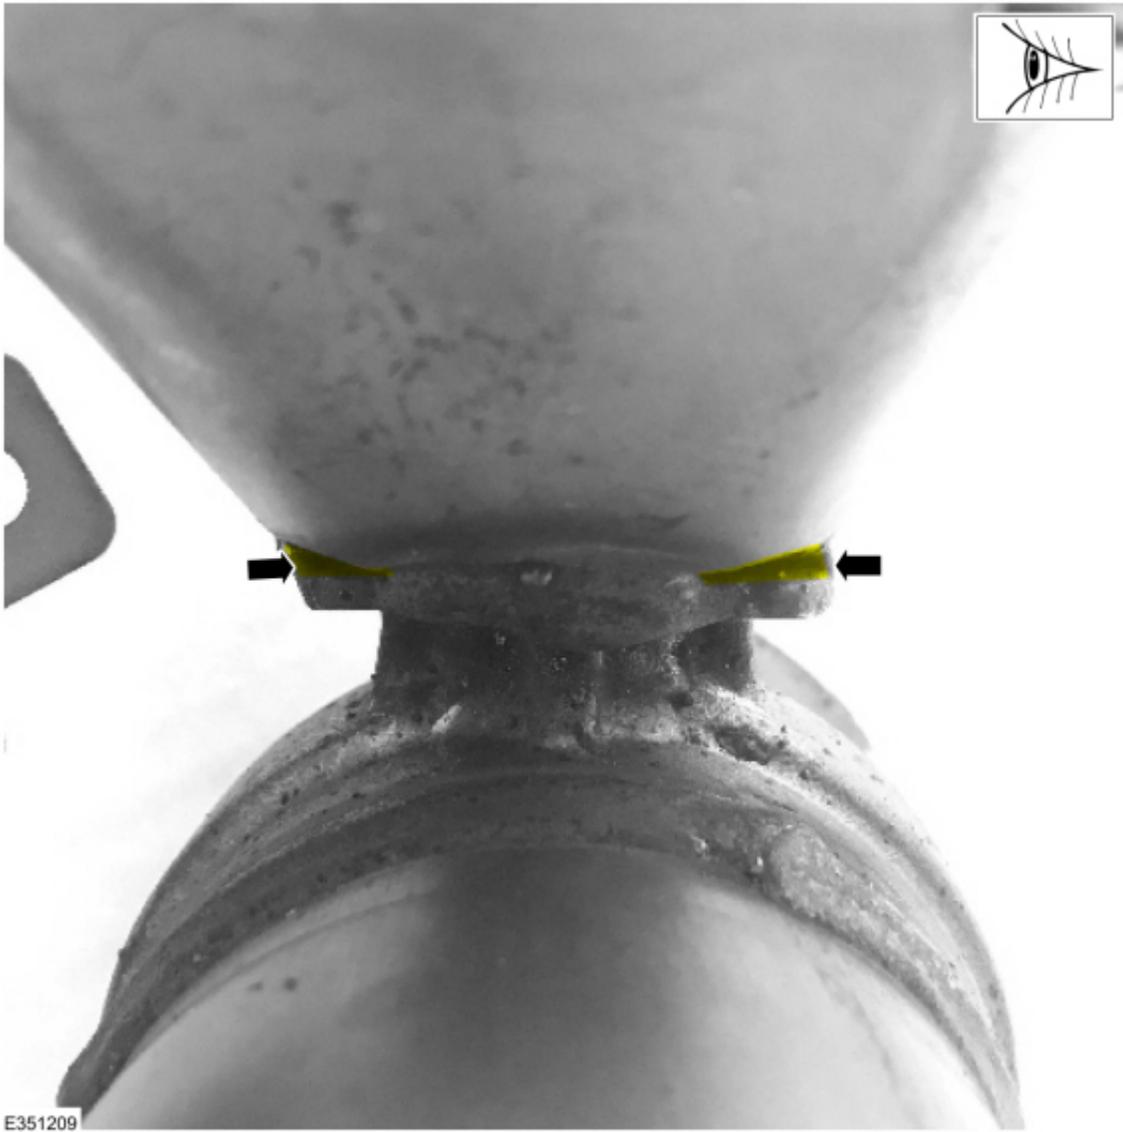
- (1). Yes - proceed to Step 3.
  - (2). No - proceed to Step 5.
3. Inspect the bracket on the tailpipe to which the exhaust actuator mounts. Make sure the bracket is mounted properly to the tailpipe by attempting to insert a 1 mm (0.39 in.) feeler gauge at the base of the bracket where it is welded to the tailpipe. Figure 1 shows a bracket that is properly welded. A feeler gauge cannot be inserted between the bracket and the boss to which it is welded. Figure 2 shows a bracket that is improperly welded, leaving room for the feeler gauge to be inserted.

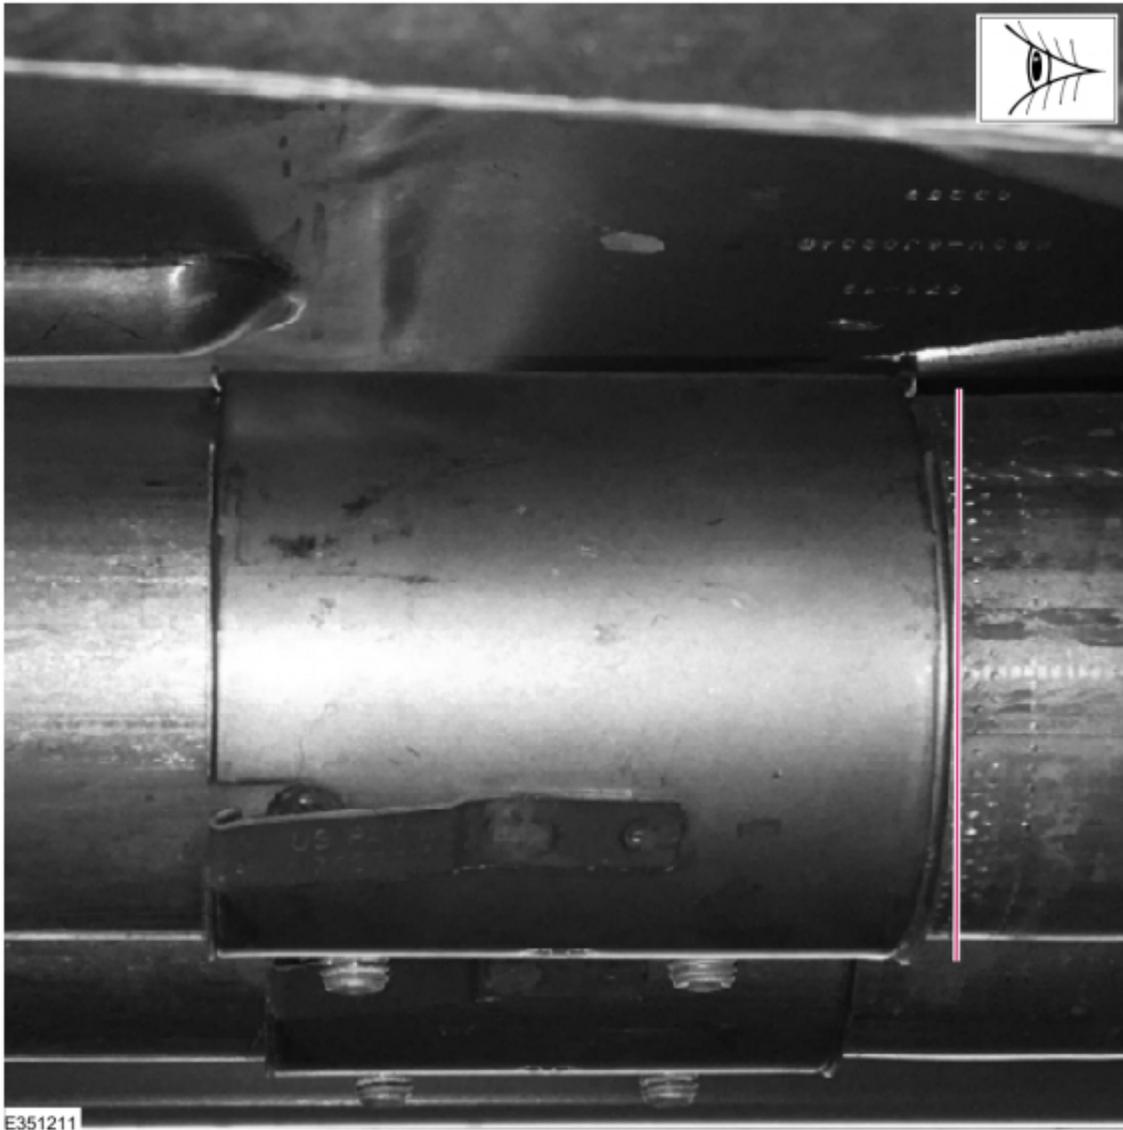
Figure 3

4. If this feeler gauge can be inserted between the bracket and the tailpipe at any point where the bracket and tailpipe meet, replace the muffler and tailpipe.
5. Inspect the muffler and tailpipe for proper position in the exhaust clamps that secure them to the rest of the exhaust system. Make sure the knurled area of the tailpipe meets the exhaust clamp as shown in Figure 3. If the knurled area of the tailpipe does not meet the exhaust clamp as shown in Figure 4, loosen the clamp and shift the muffler and tailpipe forward until the knurled area meets the exhaust clamp.

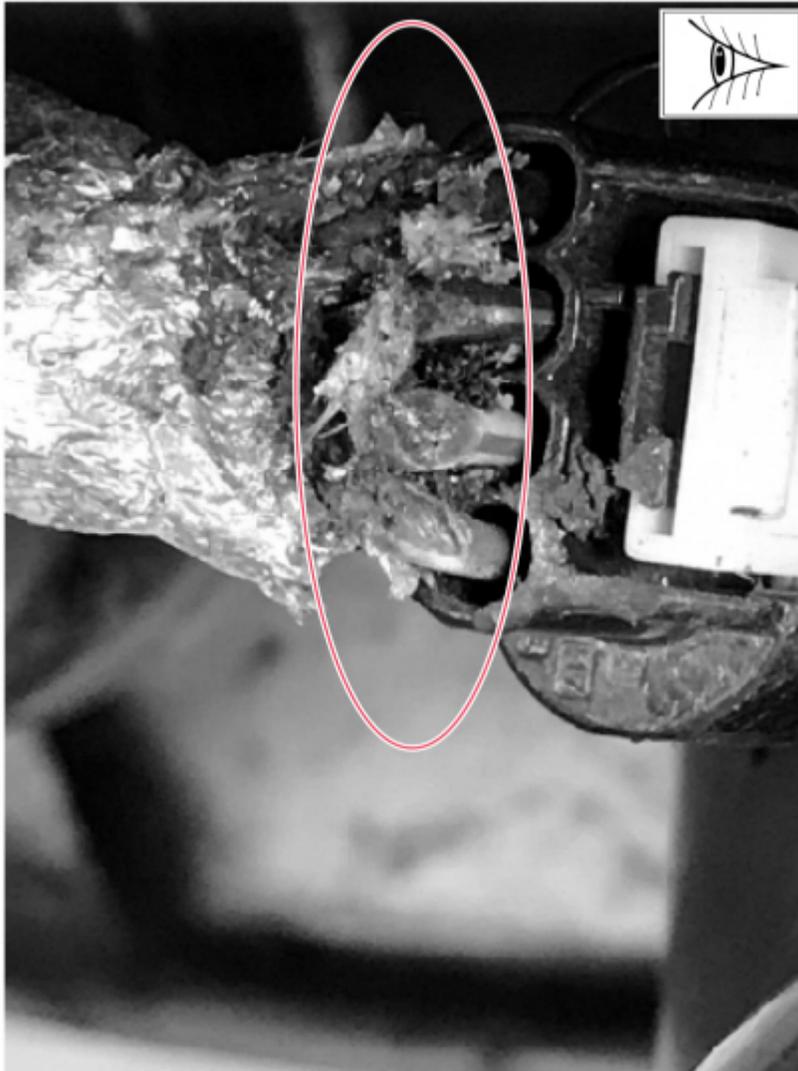
Figure 5

6. Inspect the wiring harness near the area of the tailpipe actuators for signs of damage or chafing as shown in Figure 5. Repair as necessary. Refer to Wiring Diagram, Section 5.
